## From Mexico to Canada with a Stop in Detroit; A Case Study in Recapitalization

Problem: Relocate three late vintage automotive production grinding machines from Mexico to Canada and retool the machines to process different components, reduce cost and provide faster return on investment.

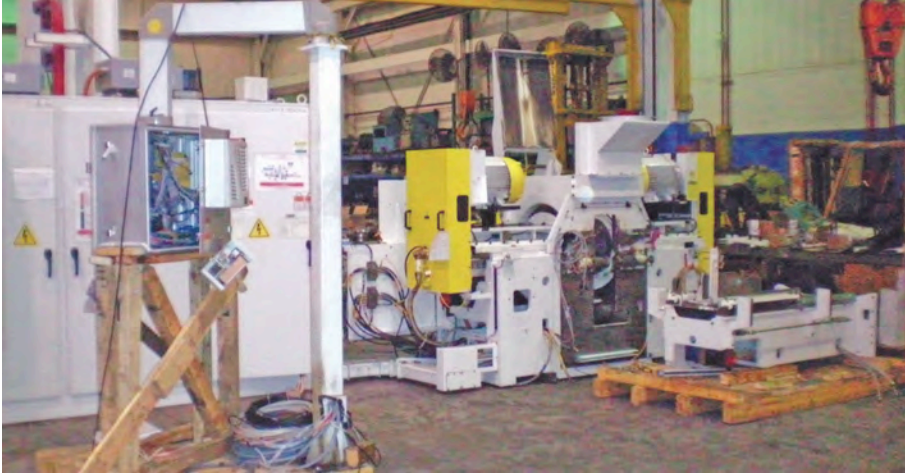
The grinding cells were disassembled at the plant in Mexico. All of the subsystems had to be removed and the grinders had to be partially disassembled in order to ship the machines to C & B. This also included disconnecting the machine's main electrical panel and the operator console. The cells were received basically in pieces with damage to several areas due to the long journey. Upon receipt of the

Grinding Cell as Received at C & B

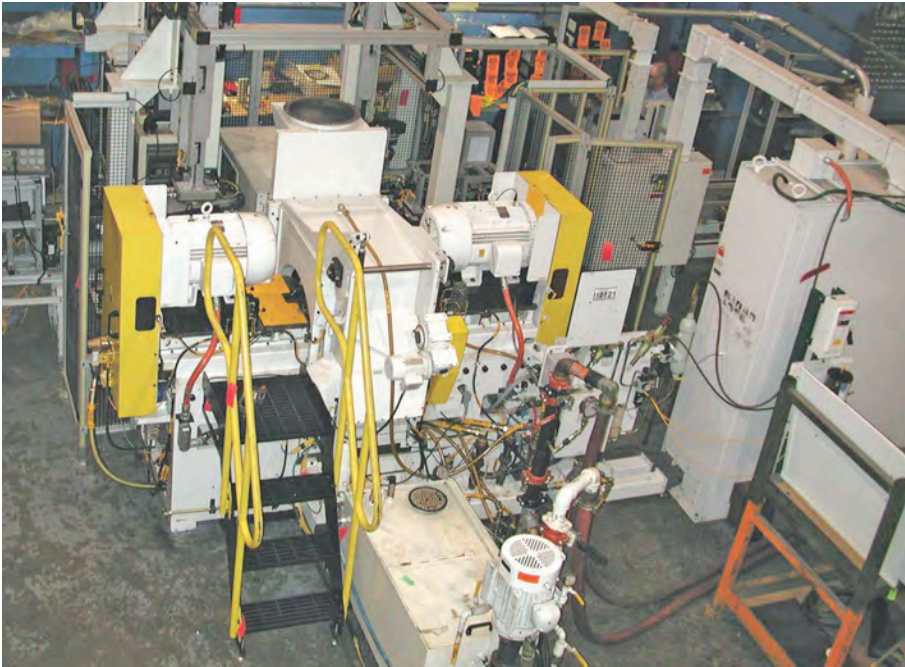
Reassembled Complete Cell

The automation and gaging systems were received after retooling and spotted in correct (rough) position relative to the grinder. After the new tooling was installed, necessary new (CSA compliant) control components installed and the system checklist was completed, the cell underwent a very lengthy debug process with engineers and skilled machine builders working in unison.

Once auto cycle was debugged, final alignments of the automation system were performed. The machine cycle was slowly sped up and tested repeatedly. Once eight hours of continuous trouble free operation was met, the grinding wheels were installed, dressed and optimization of the actual grinding cycle commenced. All in all, the debug and testing phase lasted almost one month, which is not unusual for such complex machining cells.
